Site/Project Location: MP 75 to 92 Spread 7-8

Date of Inspection: 13 September 2016

Inspected roughly 13 miles of pipeline ROW approximately 17 miles south of Beulah ND in Mercer County.

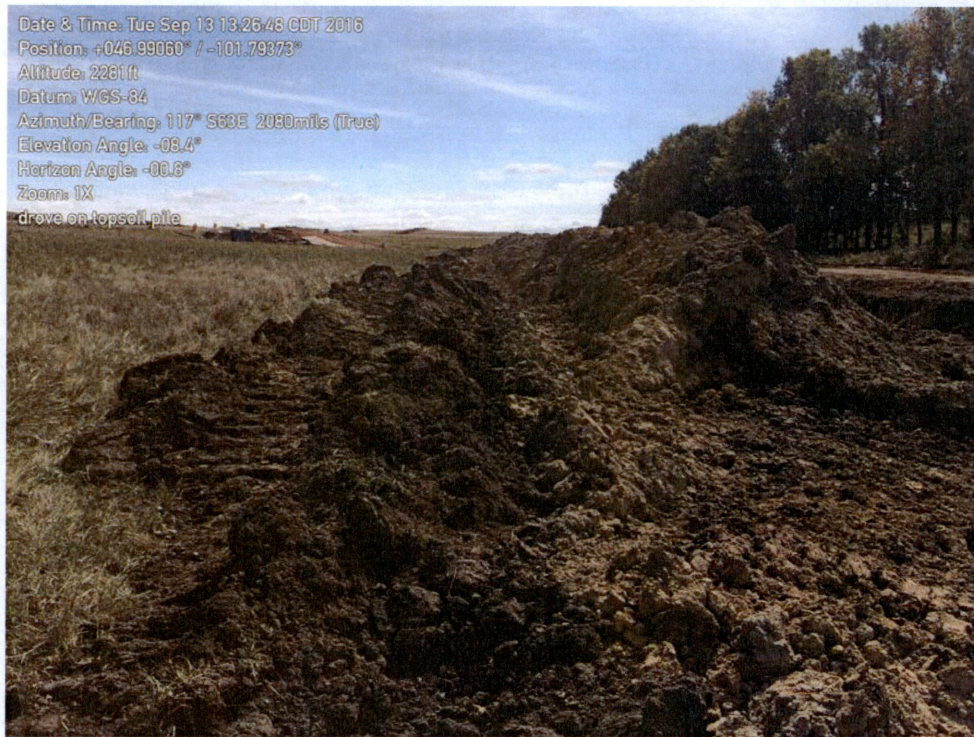
Topsoil and subsoil segregation was adequate for most the ROW inspected. Topography was generally steep, rolling hill landscape. Topsoil depth was 1-3" in some areas while other areas were as much as 12". One area had a dozer drive over the topsoil and subsoil piles, causing a mix. Three (3) areas exist where subsoil on vegetation was also observed typically in 20-25 foot strips and likely occurred during initial topsoil segregation. Other very limited areas of mixing appeared to be associated with installation of stormwater slope breaks after trench backfill. Storm-water BMPs, particularly silt fences, need minor maintenance i.e. re-stapling or replacement performed near a few waterbody crossings. Storm-water BMPs overall were properly installed and in good working condition. ROW drainage points protected with straw bales or silt fence.

Three (3) short areas of topsoil / subsoil missing or subsoil piled on vegetated surfaces. One area had a heavy equipment drive over mixing topsoil and subsoil piles. Some silt fences needing re-stapling.

Report Photo #1 "Topsoil Driven over, Soils Mixing at M.P. 92":

Will look for inspection results and prompt repair next time stormwater inspections documents are checked.

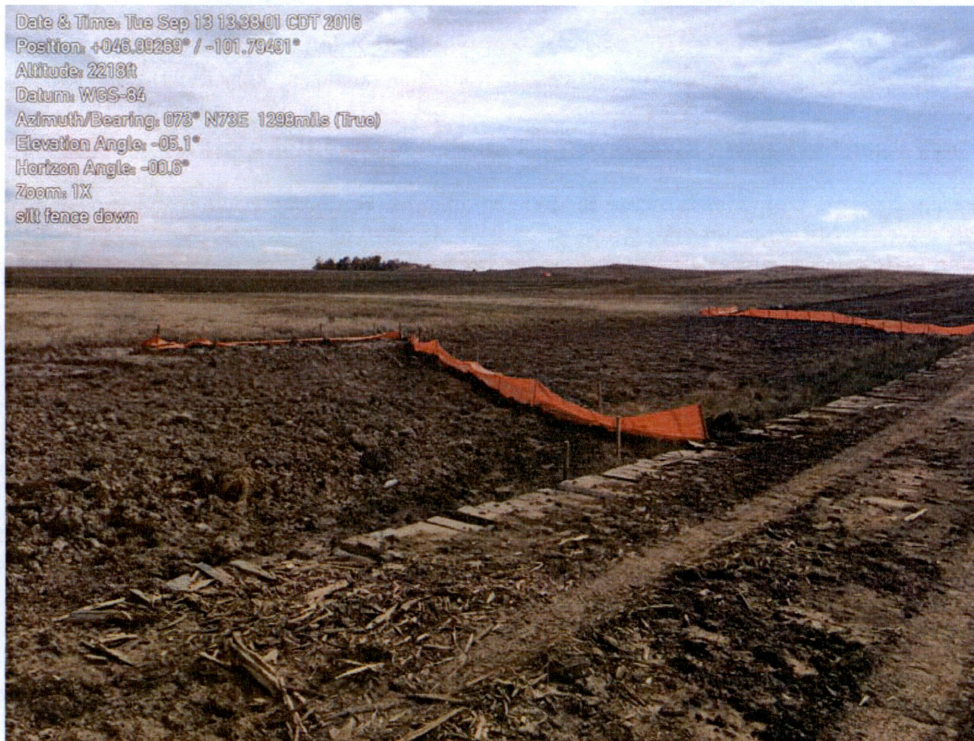
Report Photo #2 "Silt Fences Down:

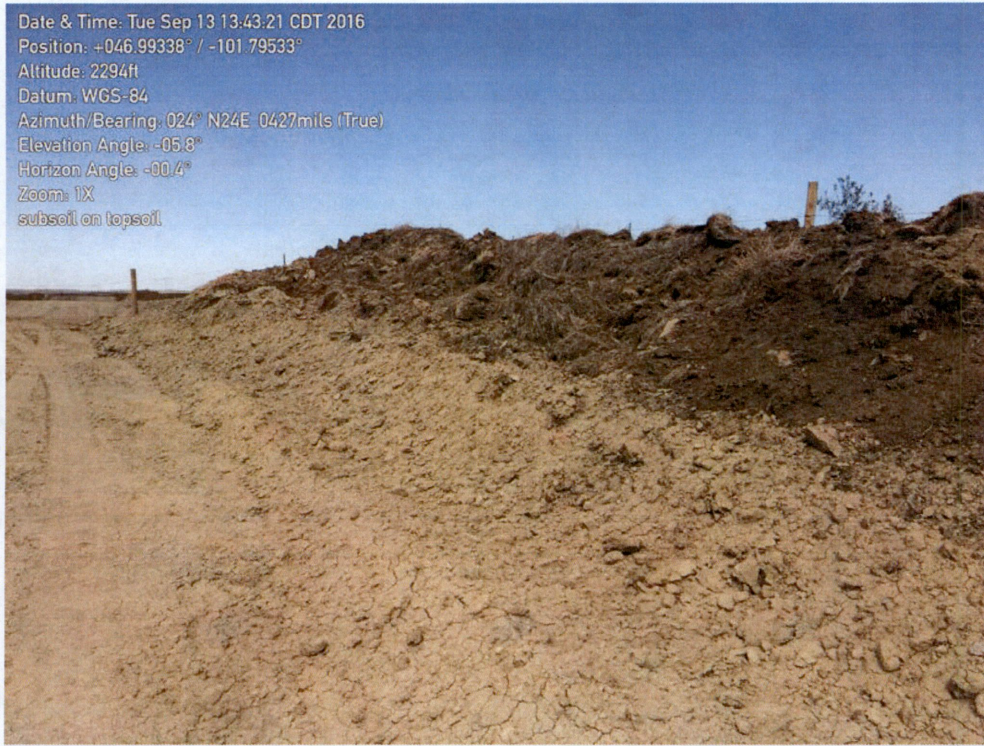
Report Photo #3 "Subsoil Plowed onto Topsoil at M.P.91.25:

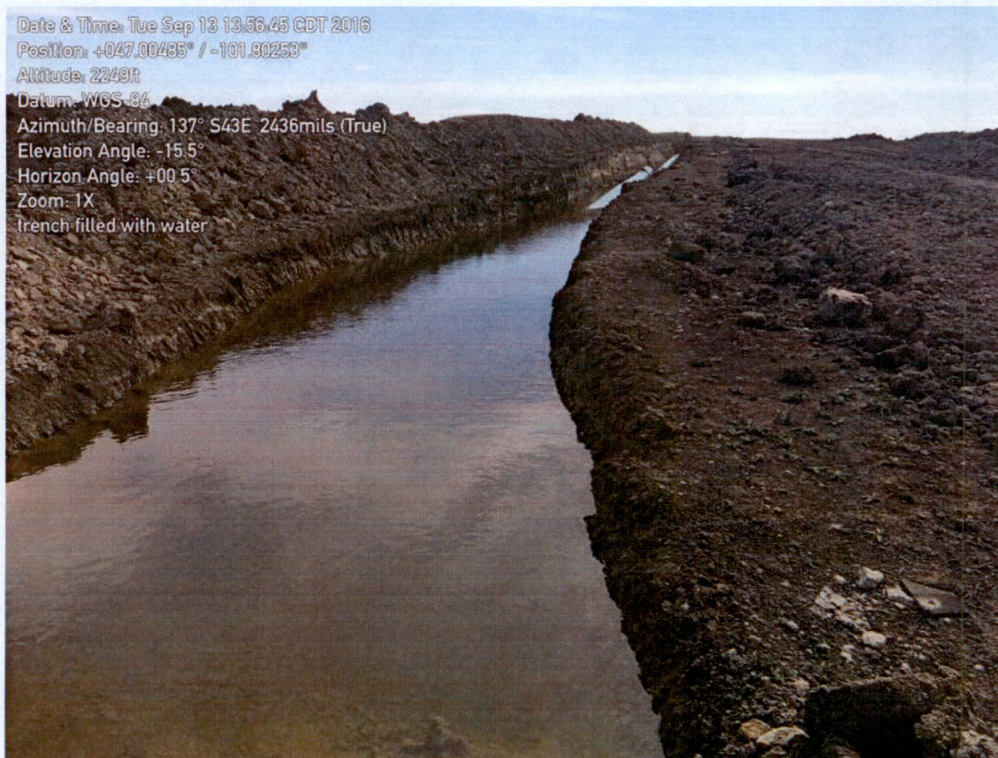
Construction activities were shut down during site visit. Pipe was generally in trench with exception at few locations. Trench was backfilled with subsoil back to subgrade on majority of ROW. Multiple open trench areas filled with water. Many areas on ROW where ROW boundary survey stakes were not visible. Exclusion zones were labeled with yellow signs and colored pennant string flags.

Report Photo #4 "Trench Filled with Standing Water:

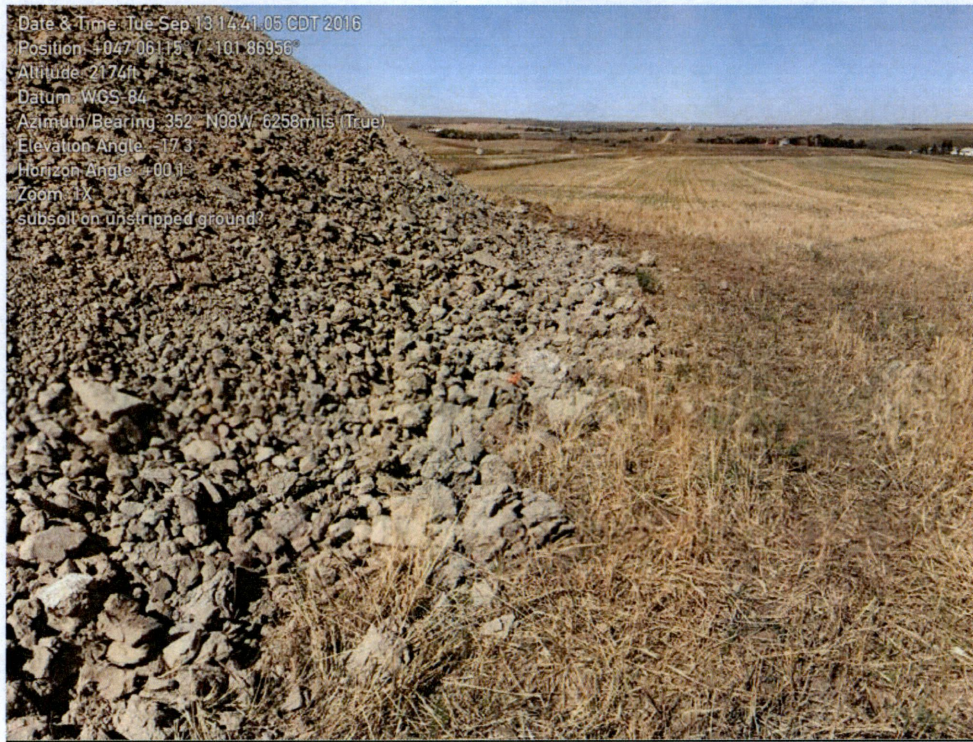
Report Photo #5 "Subsoil On Top of Vegetation, No ROW Stakes":

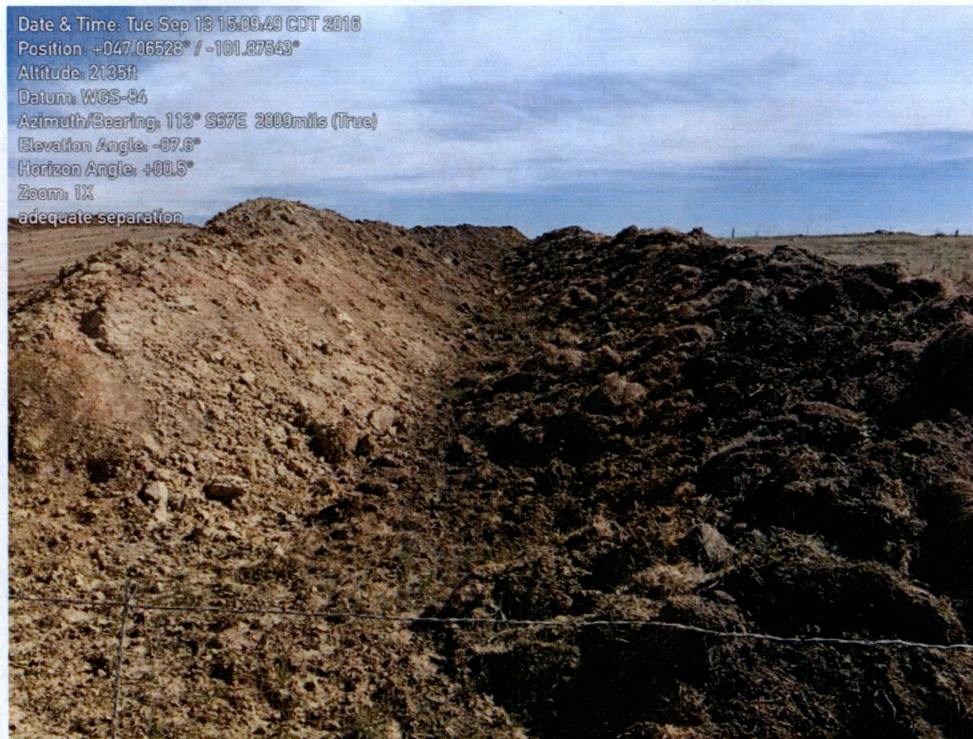
Report Photo #6 "Adequate Topsoil-Subsoil Separation":

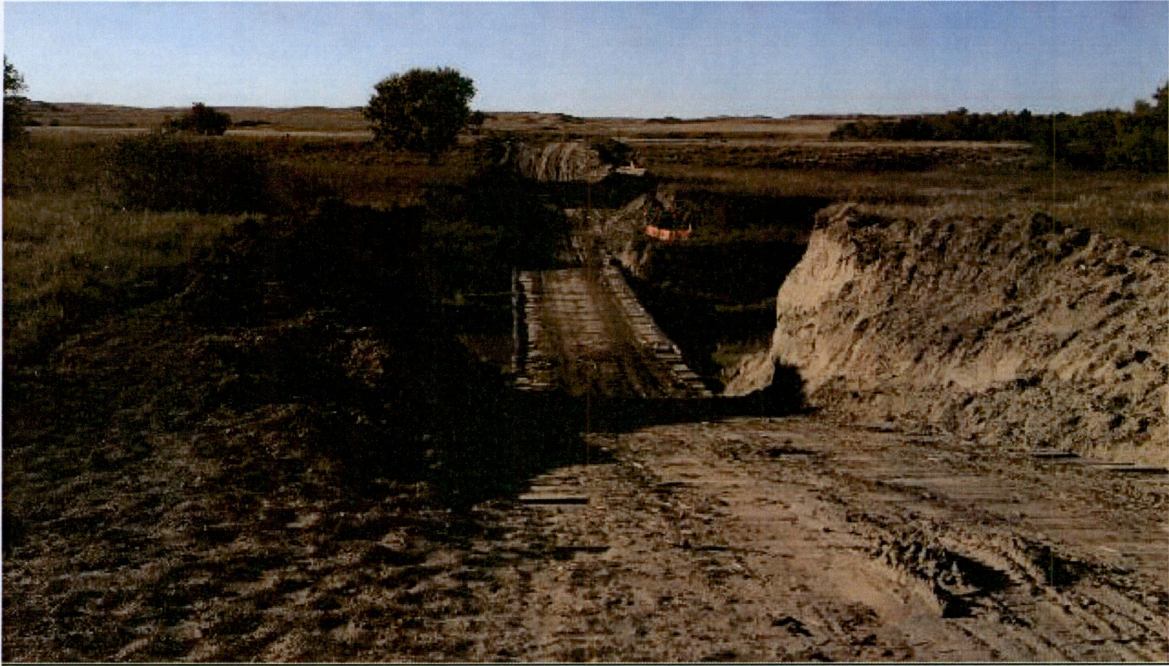
Report Photo #7 "Knife River Crossing":

Open trench areas observed and measured were at specified depth or deeper. Two water crossings noted with narrowed work areas with riparian vegetation protected by silt fences. No active HDD operations noted. Roughly 30 foot wide access road was created between the Knife River bore pads using matted bridge pads.
